The Hive: Carrick on Shannon

Invasive Species Survey Report

Prepared for: Cooney Architects

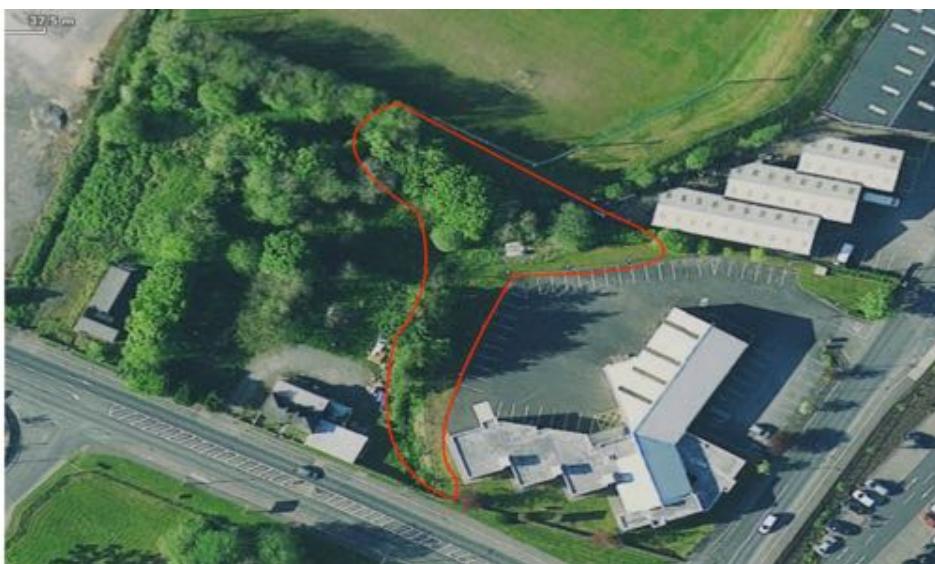
The site under study is a portion of the grounds of *The Hive*. These include car parking area, adjacent landscaped area, waste ground adjacent this, boundary vegetation (treelines, hedgerows) and adjacent lands. The area surveyed is shown in the aerial photograph below.

Fig. 1. Area under survey. Surveyed area shown inside the red lines.

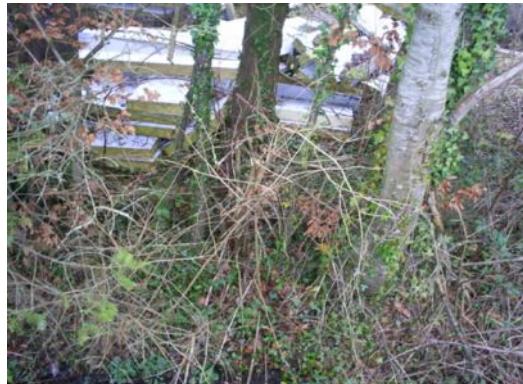
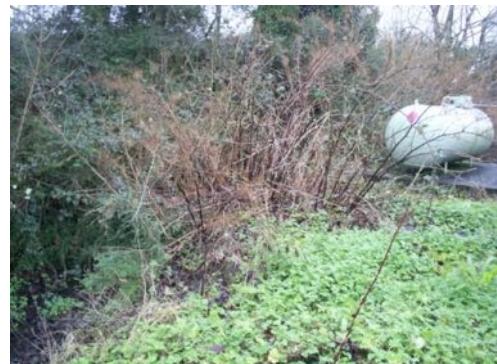
This invasive plant species is found along the banks of the small wet ditch that occurs within the site. It appears to have spread when these banks were being reformed or shaped. Along the eastern bank of the stream, the knotweed extends northward for a length of c. 9m. There is also a mature stand on this bank, around 7m to the north of this. On the western side of the ditch, knotweed extends for a similar length under the mature treeline here and up to and around the corner of the ditch with an adjacent property boundary. Finally, there is a mature stand of Japanese knotweed c. 2m to the west of the LPG fuel tanks toward the northern boundary of the site. Again, this is located on the bank of the wet ditch here.

Above photographs show Japanese Knotweed on corner of wet ditch and beside LPG tanks.

Japanese Knotweed appears to have been on this site for several years. The stands here are mature and there is evidence that this plant has spread within the site. However, to date the spread has been along the banks of the wet ditch within the site and it has not yet spread outside the site or onto paved surfaces.

No development should be allowed within the area affected by this plant. Japanese Knotweed has the potential to have roots and rhizomes (underground stems) that extend up to 7m from the visible over-ground stems. Therefore, a provisional ‘buffer-zone’ of this distance must be maintained in which no development should occur until the plant is removed, treated or the area otherwise made safe for works. However, it is unlikely that the affected area extend this far. Growth appears confined to banks of the wet ditch and it is considered unlikely that any underground growth extends to existing hard landscaped areas.

Ideally, the plant should remain *in situ* and not be removed from the site. Removing the plant from the site requires a licence from the National Parks and Wildlife Service and would be very costly. It is recommended that if at all possible, the plant remains within the site and is chemically treated (with a herbicide) over a number of years. In order to achieve this, any developments must take place outside the affected areas. If any development within the affected areas must take place, it is recommended that any spoil or excavated materials are kept within the site if at all possible.

It is recommended in the short-term that a further site visit is held with both ecologist and architect present, in order to determine which parts of the site might remain undisturbed and where any direct action is absolutely required. A management plan for this species should then be drawn up.

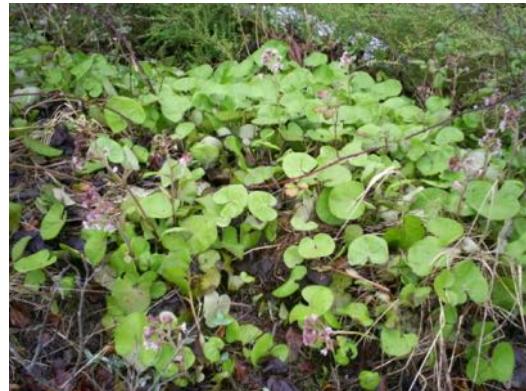
This invasive plant species is found over a scattered area to the south of the existing car park. It occurs on both sides of the wet ditch but is mostly concentrated on the eastern side of the ditch where there was previously cleared ground. It does not appear to occur elsewhere

Winter Heliotrope close to facility car park

This plant spreads by the growth of its roots and it becomes problematic when dominates areas with native species being pushed out. Though it does provide a source of winter feeding for bees, its value is outweighed by its invasive qualities. It is extremely persistent, being able to regenerate from small parts of the roots. Continued digging of it will, however, eventually exhaust the plant. At *The Hive* it has spread over an area of bare ground and unmanaged grass. It is not listed on the third schedule of the above regulations. It is not believed to be within an area proposed for works.

It is not believed that any development is intended within the areas affected by this species. However, if any areas where this plant occurs are to be affected, measures must be taken to retain materials on site and avoid any spread of same. Machinery or plant used in this area should be cleaned *in situ* before being moved elsewhere. Again, a site visit to determine the proposed works area should be undertaken before finalising a management plan here.

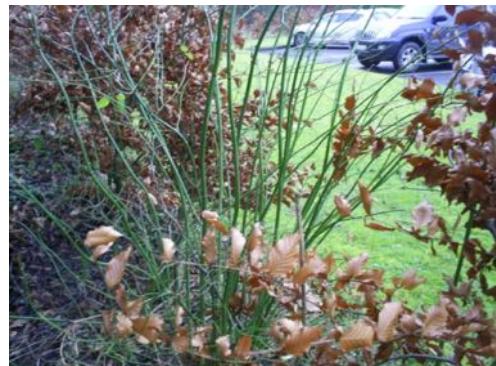
A single plant of this invasive species was found in the Beech hedging that borders the car park. It is likely that this was planted here. A fragment of a plant of the same species was found beside the northernmost stand of Japanese knotweed (JK4) but there was no evidence of this plant having spread to any other location.

Single plant of *Leycesteria Formosa* in Beech hedgerow

This plant can form dense monospecific stands and out-compete native plants in areas such as woodlands. Only a single plant of it occurs here, it is believed. It is not listed on the third schedule of the above regulations.

This single plant may readily be treated by cutting and the application of a small amount of suitable herbicide.
